Life-Safety Hazard - Door Clearances for “Residential” Type Elevators In Commercial Buildings and Residences

Identifying the Hazard

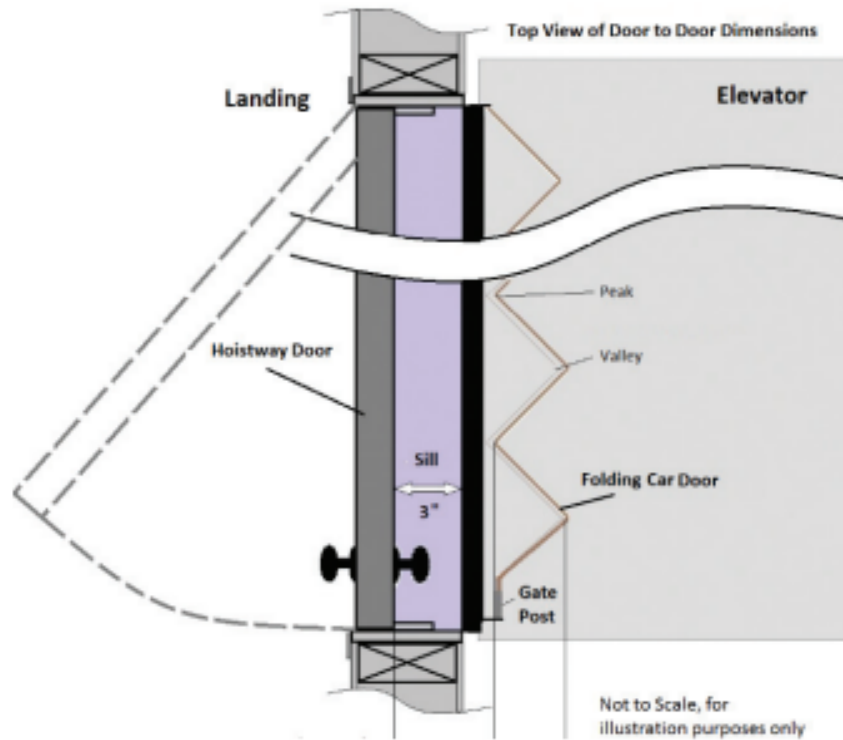
An elevator may have excessive clearance between a hoistway (landing) door and the elevator car door. The space may be large enough for a child to occupy the space in both the landing and car doorways at the same time. The elevator system will not detect the presence of a child in this space. If both the landing and elevator doors are closed, the elevator will move away from that landing if called or sent to another landing.

This diagram illustrates the condition. (courtesy *Elevator World*)

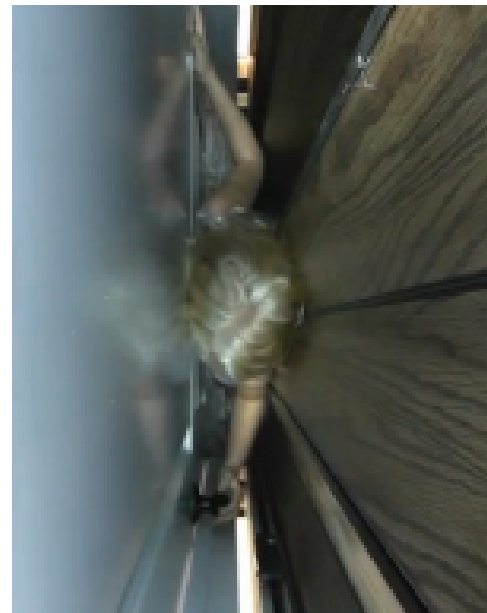
A seven-year-old child in the space with the landing door and elevator door closed

If a child occupies the space between the doors and the elevator is called to a floor below, the child will be caught between the top of the elevator doorway and the landing floor sill.

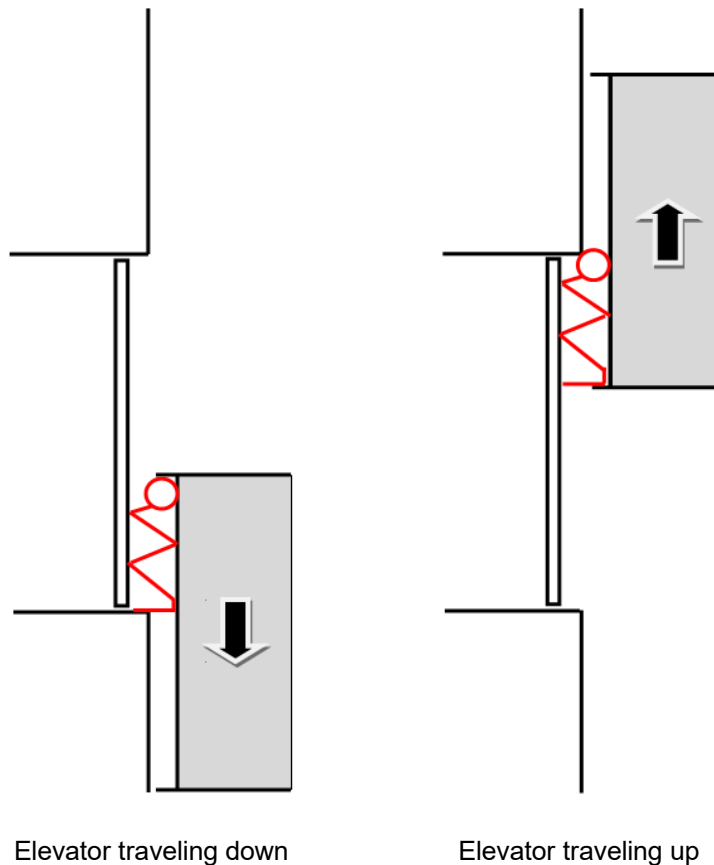
If the elevator is called to a floor above, the child will be caught between the floor of the rising elevator car and the hoistway door header of the landing.

Elevators that can lift several hundred pounds will impart that force upon any obstruction such as a child in this space.

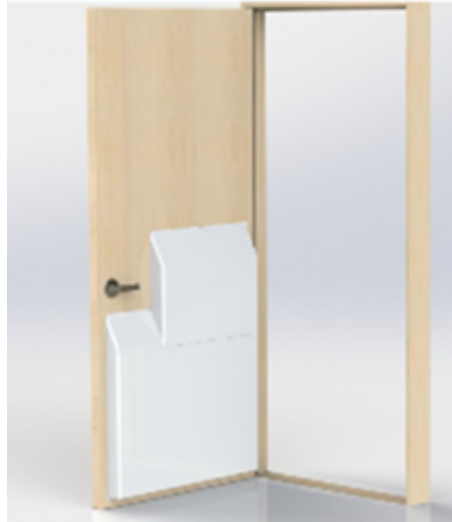
A lower-cost solution is the installation of a space guard on the elevator-side of the landing door. A space guard can effectively occupy the space between the landing door and elevator door that a child might otherwise occupy.

Space guards may be made of plastic, clear acrylic, wood, or other suitable material. The top of the space guard should be beveled at 75 degrees to the horizontal to prevent a child from standing on the top edge or a horizontal surface.

Many elevators were required to have space guards by code when installed however its is possible that space guards have been removed. Where a space guard was required, it may not be removed.
