**State of Wisconsin**  
**DEPARTMENT OF SAFETY AND PROFESSIONAL SERVICES**  
**ELECTRICAL PROGRAM**

## **FREQUENTLY ASKED QUESTIONS**

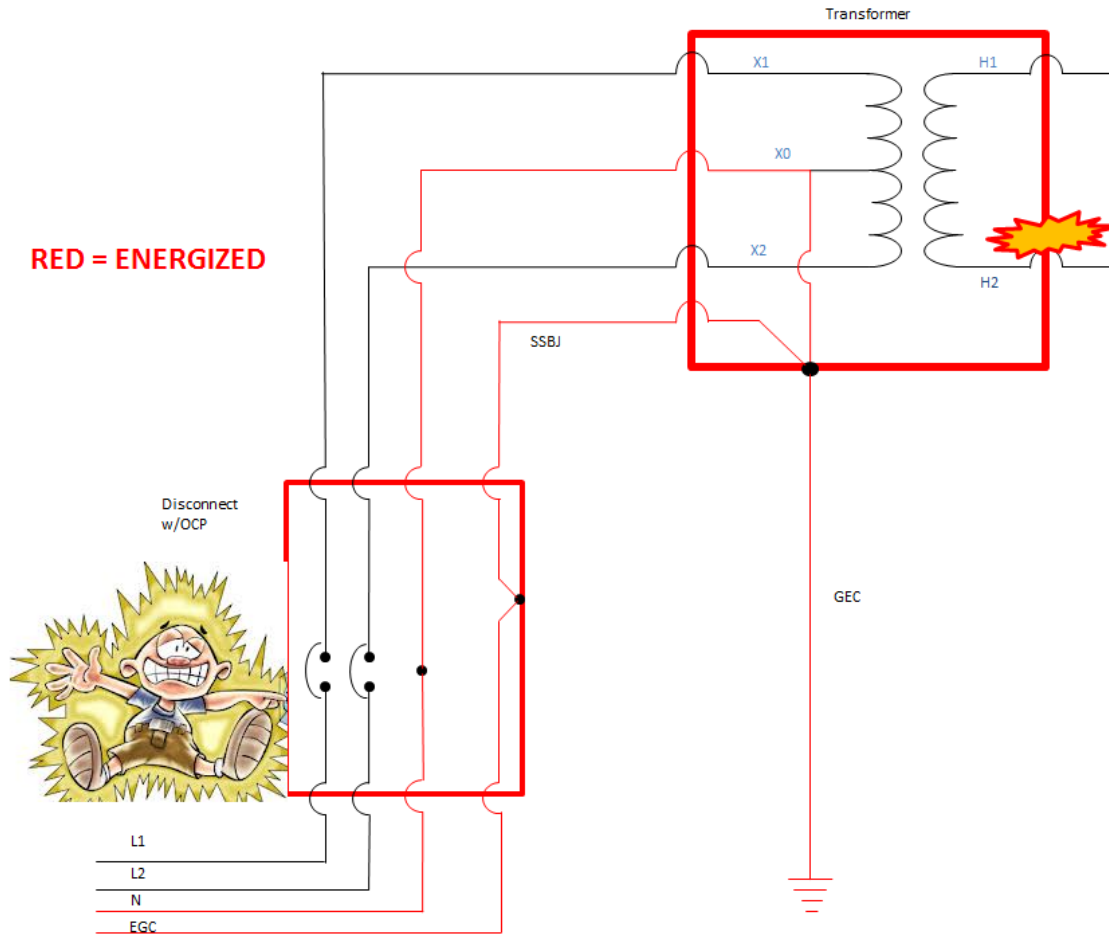
Isolation transformers are not to be allowed. If there was a fault on the primary, there would be no way for the fault to clear and it would energize the GEC, neutral, supply side bonding jumper, and equipment grounds downstream. According to the figure below, if the fault occurs on H2 as indicated by orange flash on the drawing, all lines and equipment highlighted in red would become energized with no way to clear the fault. I think we could use 250.110 to require the equipment ground to be ran with the primary.

No. NEC 250.30(C), 250.30(A)(2), and 250.110
